# *Inspect Des Moines* Property Inspection Report

4625 Buckpasser Ave, Sampleville, Iowa 50263  
Inspection prepared for: John Doe  
Real Estate Agent: Jane Doe - Sample Realty

Date of Inspection: 6/20/2017 Time: 1:00 pm  
Age of Home: 10 years Size: 1780 sq ft  
Weather: Overcast

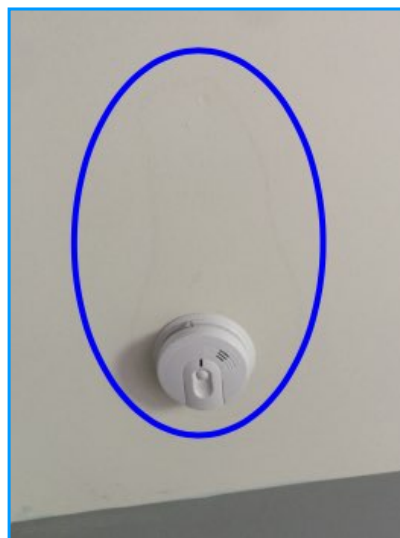
- Moisture stain noted on the ceiling in large spare bedroom. It tested dry at the time of the inspection. It is located below the attic furnace which appeared to have a condensation problem which was repaired. Recommend checking with current owner or hiring a qualified professional for further review.

Staining on ceiling under attic air handler.

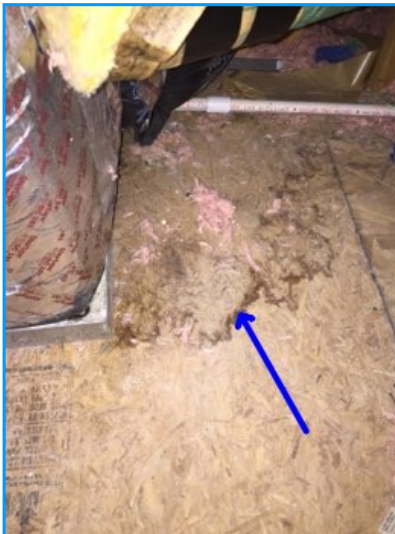
- Staining noted under the condensation line. It appears the current owner has made repairs. The stains tested dry. Recommend asking current owner and monitoring in the future for any further moisture.

Air handler staining on sub floor

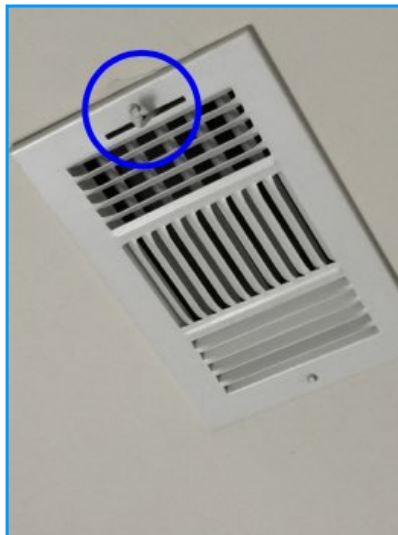
Observations:  
 • The return air supply system appears to be functional.  
 • There is a bent return air grill lever that prevents closing of the vent.

Bent adjustment lever won't allow vent to be closed.

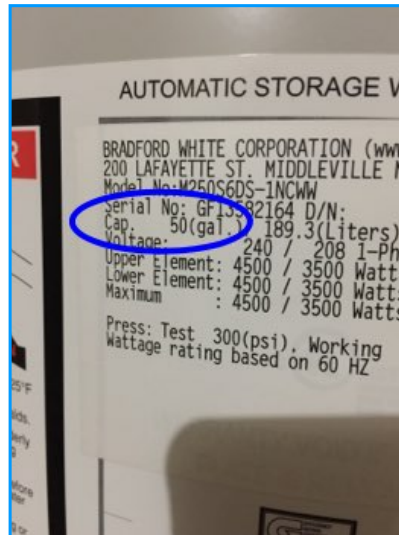
Observations:  
 • 50 gallons

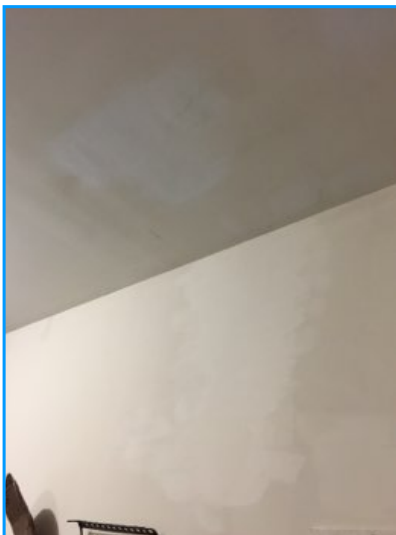
Observations:  
 • Wall and ceiling patch work as described in seller disclosure form. No active moisture at the time of testing

Wall and ceiling patchwork.

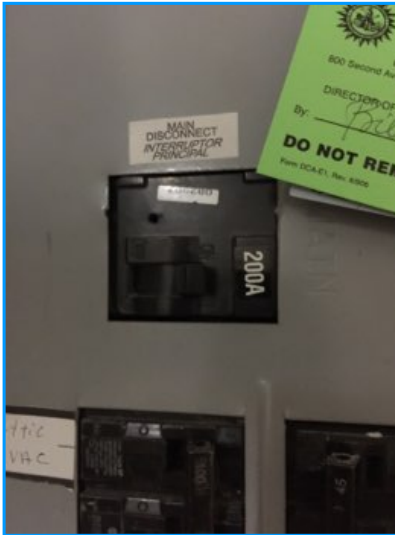
- 200 amp

Main Electrical Shut Off Switch

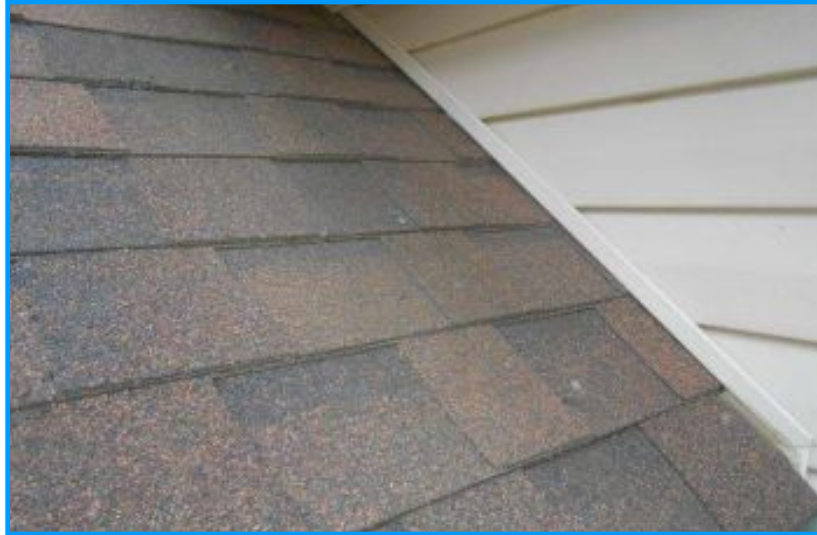
- No major system safety or function concerns noted at time of inspection.
- Exposed nails on roofing material. Recommend sealing all fastener heads.

Exposed nail heads.

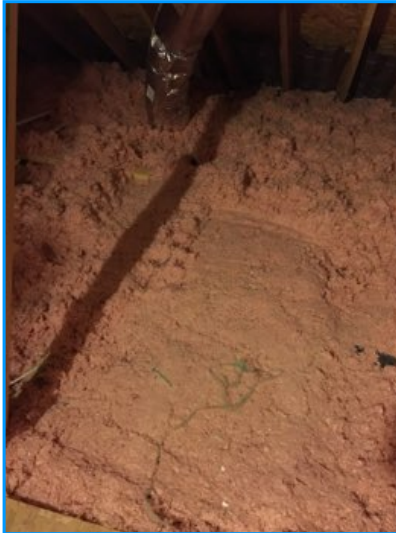
- No insulation over attic hatch; recommend installation, then sealing hatch with caulk to minimize heat loss.
- Fiberglass insulation appears adequate.

Attic Insulation

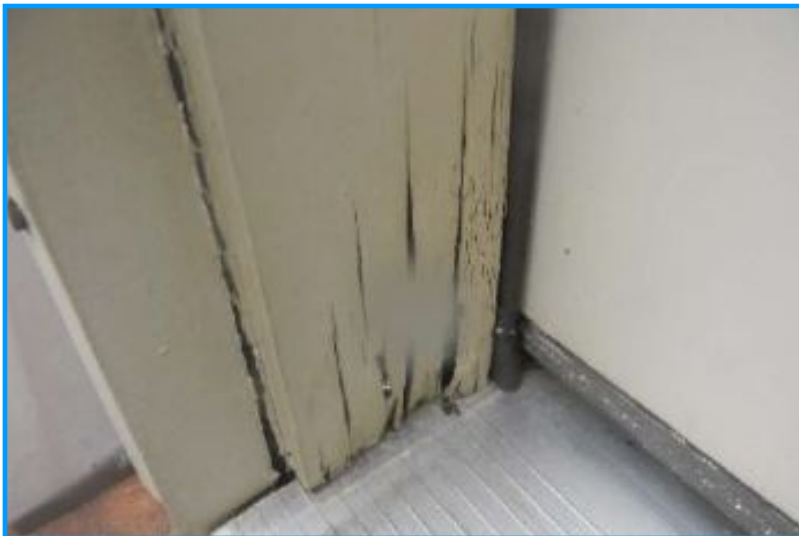
- Appeared in functional and in satisfactory condition, at time of inspection.
- Hardware is damaged on rear patio door. Recommend replacing to prevent water infiltration.
- Wood deterioration observed. Suggest repairs/replacement as needed.

Rotted door jamb.

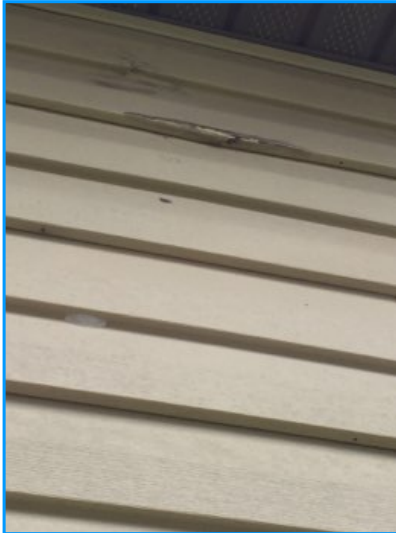
- Metal trim at south side of house needs to be resealed. Vinyl siding has some holes that have been sealed. Recommend monitoring and re-sealing as necessary.
- Fresh paint was observed. Although it improves the appearance, it may conceal any possible defects or prior repairs.
- Dryer vent terminates into vented soffit over the front entry. Recommend a qualified professional review and properly terminate it outside.

Monitor sealant and maintain as necessary.

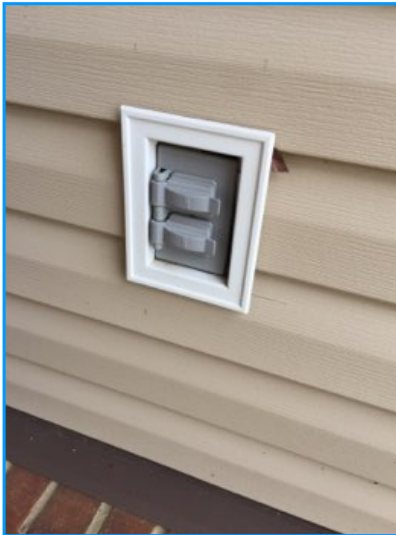
Observations:  
 • No weather proof cover at front porch outlet. Recommend adding to protect the outlet.

Recommend adding weather proof outlet cover.

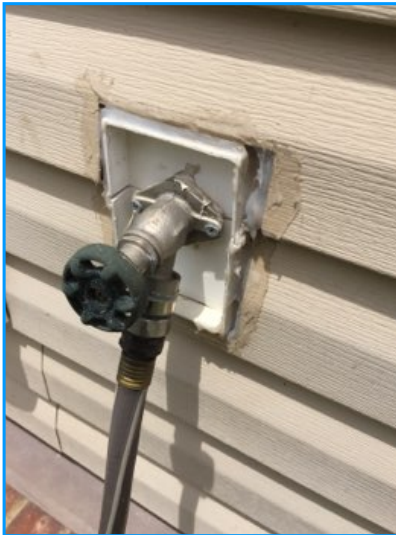
- Hose bib at south side of house needs sealant around cutout.

Recommend monitoring and resealing as necessary.
